## **POST-EVALUATION OF THE GANGES LEFT BANK EROSION PROTECTION PROJECTS FROM PANKA NARAYANPUR TO INDO-BANGLADESH BORDER**

Md. Abul Ala Moududi<sup>1</sup>, Pintu Kanungoe<sup>2</sup>, Md. Alauddin Hossain<sup>1</sup>, Md. Johurul Islam<sup>3</sup> and Mohammad Mehedi Hasan<sup>4</sup>

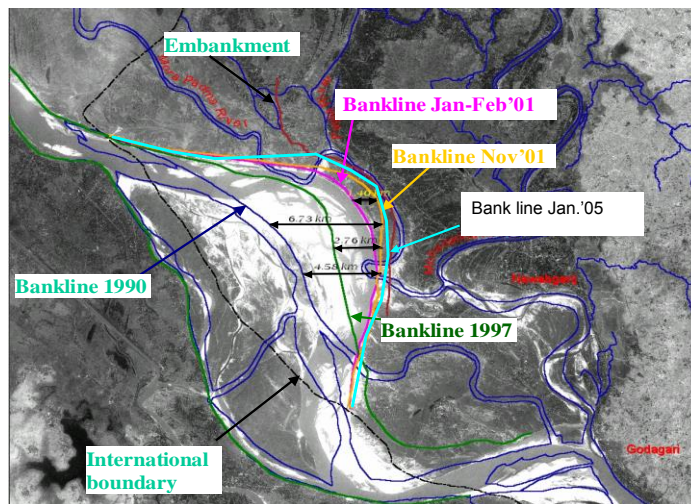
These critical morphological situations of the river systems may put the Rajshahi-Chapai Nawabganj region at risk. Lateral bank shifting (of about 7 km) due to progressive erosion is shown in Figure 2.

**Figure 2.** Bank line shifting of the Ganges River at Panka Narayanpur to Indo-Bangladesh border (Source: IWM 2006)

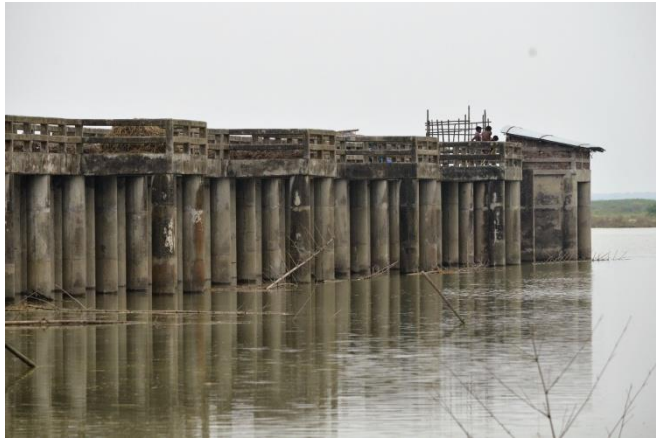
Field visit revealed that spur #3, #4, #5 and #6 are still existing in the field and functioning well some of which (spur #5, #6) can be evident from Figure 5 and Figure 6. Emergency basis constructed revetment between the damaged spur #1 and #2 and another revetment between existing spur #3 and #4 are in good shape and functioning well. The revetments constructed at the downstream of existing spur #6 are also in good condition. Different types of bank protective structures such as spur and revetment constructed under two projects have positive bearing to arrest bank erosion for a 23 km long stretch of left bank of the Ganges river.

**Figure 3.** The pictorial view of head of Spur #5

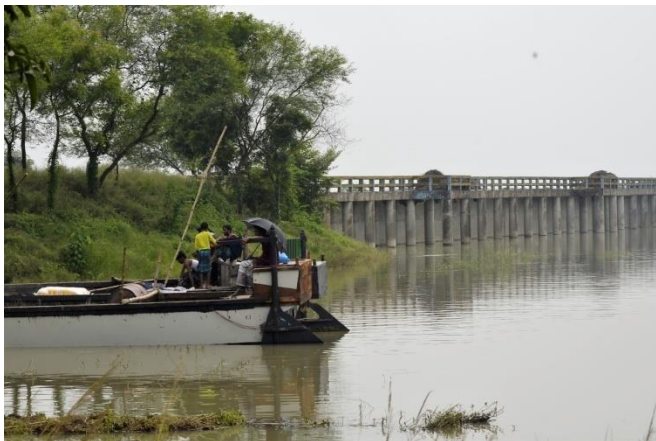
**Figure 4.** Photographic view of head of Spur #6

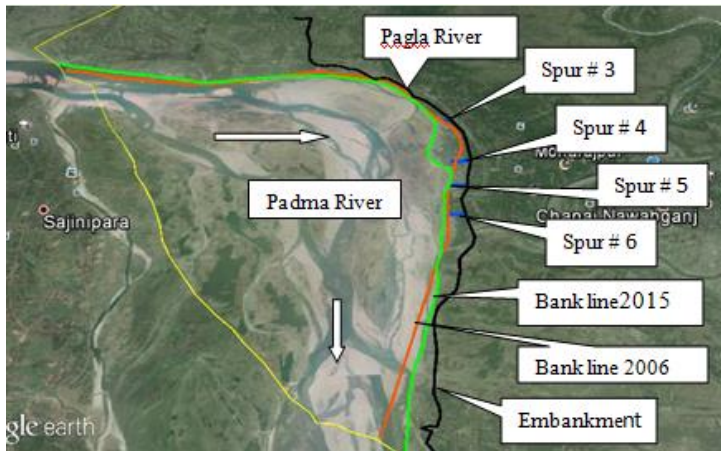
It is depicted from Figure 5 (Satellite image 2015) that, sedimentation occurred among the spurs. Main channel has been shifted from left bank to the right bank due to the combined effect of revetment and spurs erected in the exposed area. Other area remains with the left bank. At the downstream of spur #6, the bank line has been shifted to the left in comparison with bank line 2006. The bank line at upstream of spur #6 is found to be almost same for 2006 and 2015.

**Figure 5.** Bank line of the Ganges River at Panka Narayanpur to Indo-Bangladesh border (Source: Satellite image 2015)
