## ASSESSMENT OF BANK LINE SHIFTING OF SURMA RIVER USING GIS AND REMOTE SENSING APPROACH

### Abstract

**Keywords:** Surma River, Remote Sensing, GIS, Landsat Satellite, River Bank Erosion.

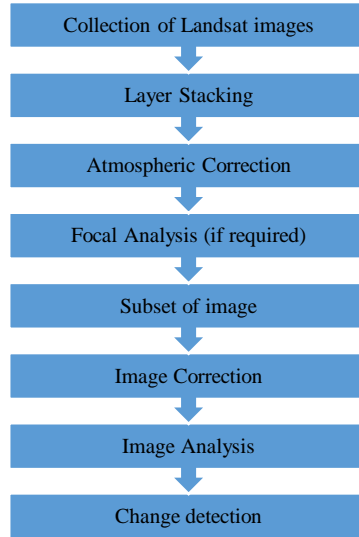
Methodology of the work has been shown in the Figure 1

**Fig 1:** Process flow diagram

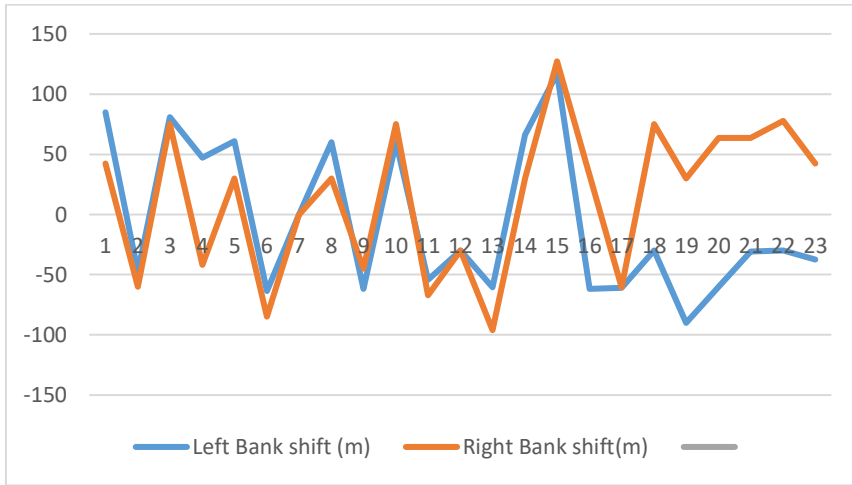
In the figure below the downward gradient means shifting toward left and upward gradient means shifting toward right. The numbers indicates the location.

**Fig. 3:** Bank line shifting of the River (1994-2006)

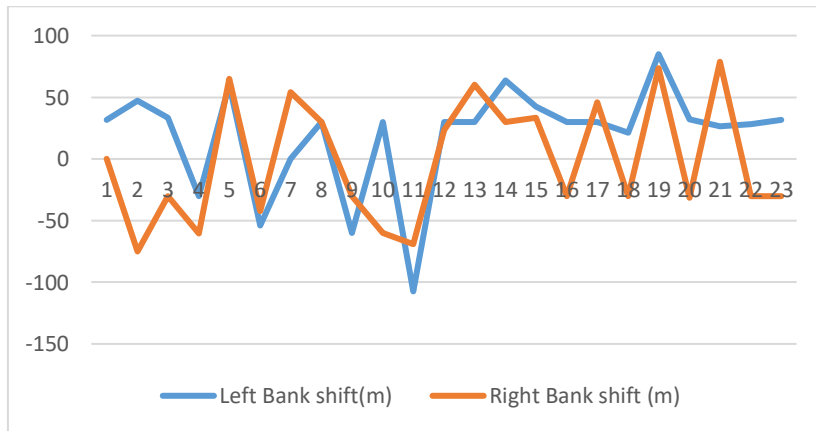
**Fig. 5:** Bank line shifting of the river (2006-2018)
